**FLAT 9, WOODGATE COURT, 98 STAFFORD AVENUE, HORNCHURCH, ESSEX, RM11 2EX**

In accordance with your instructions, we have carried out a quarterly desktop valuation of the above mentioned property.

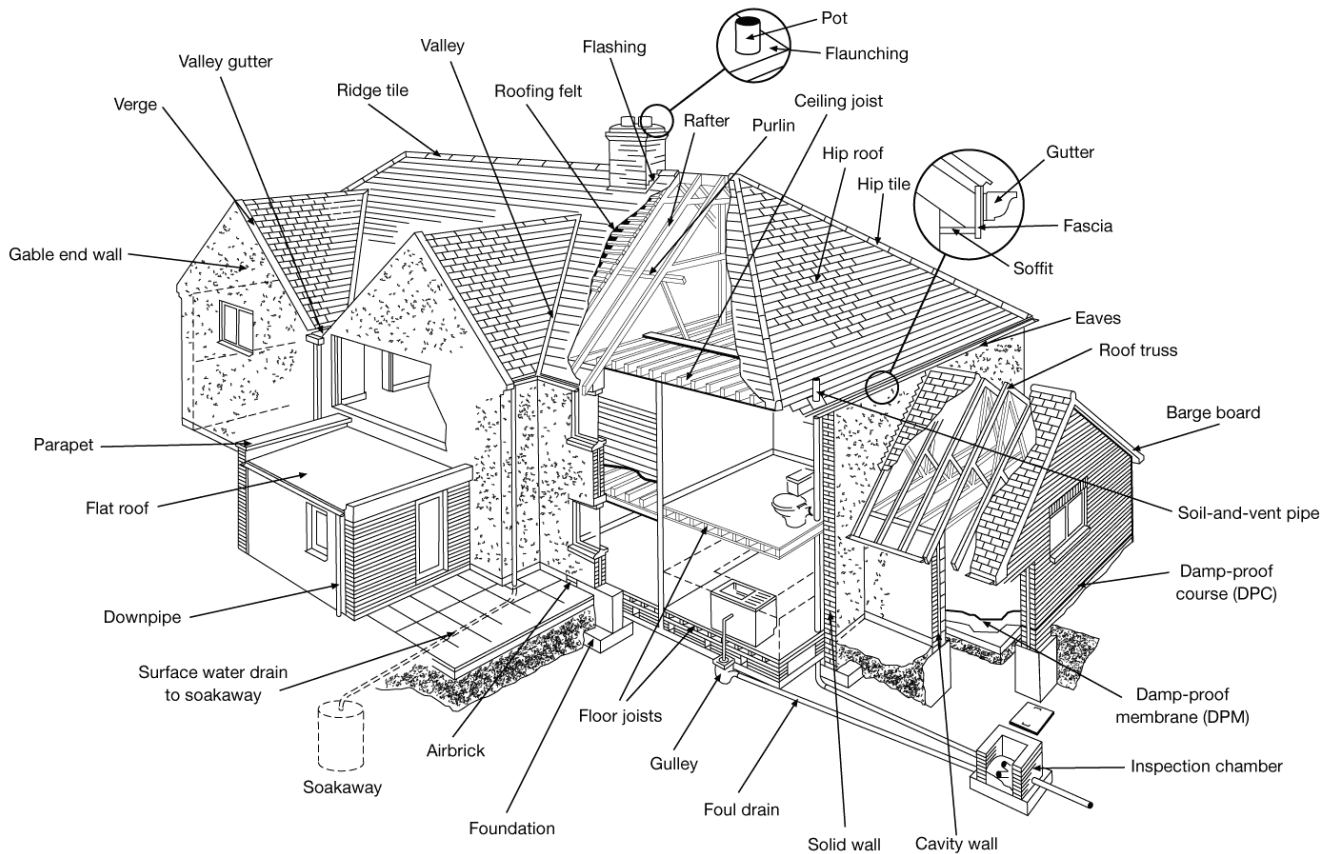
# Typical house diagram

This diagram illustrates where you may find some of the building elements referred to in the report.
