**RE: 34 WATERFORD HOUSE, THORNEY MILL ROAD, WEST DRAYTON, MIDDLESEX UB7 7DL**

**DESKTOP VALUATION: 34 WATERFORD HOUSE, THORNEY MILL ROAD, WEST DRAYTON, MIDDLESEX, UB7 7DL**

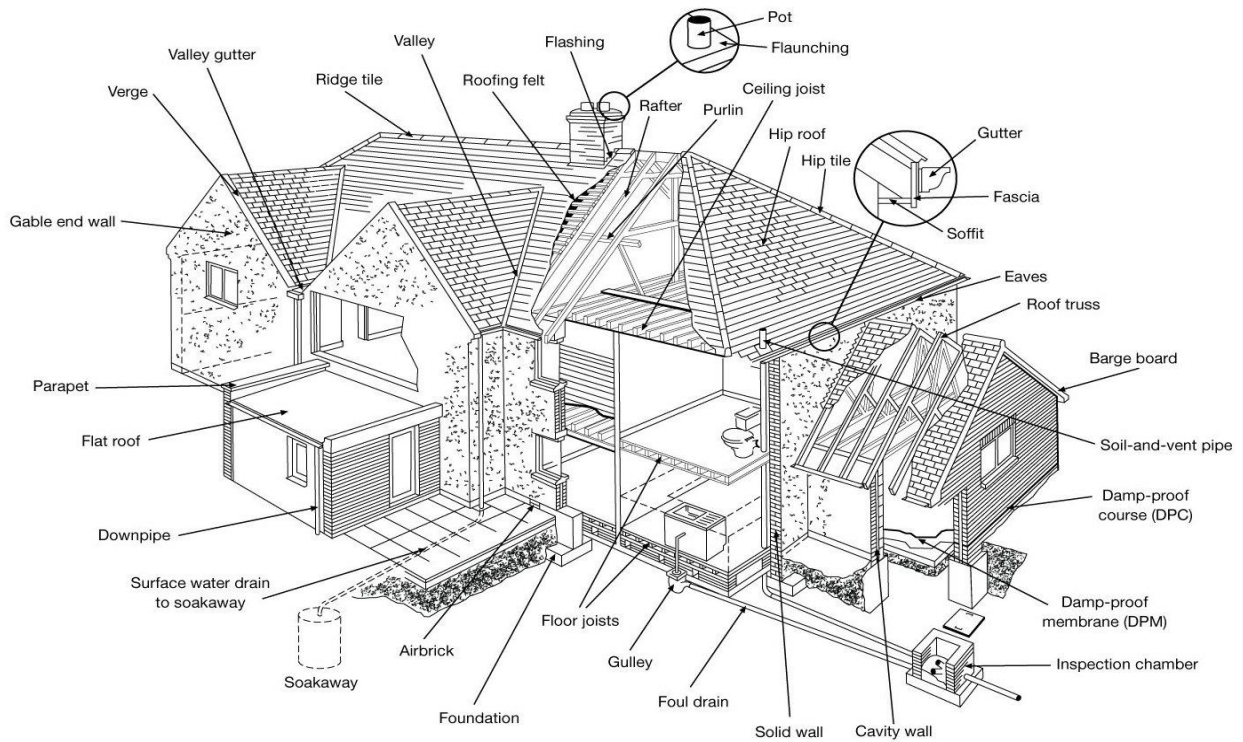
# Typical house diagram

This diagram illustrates where you may find some of the building elements referred to in the report.
